# WDC Marvell

## 1. Drives supported by the WDC Marvell utility

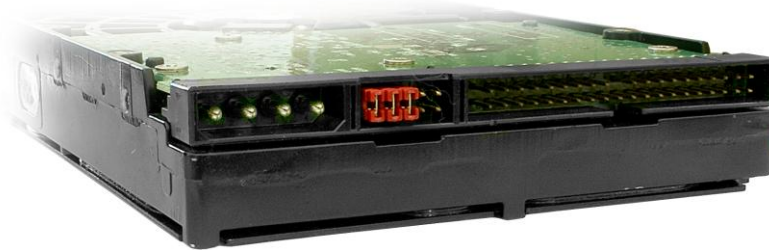
*Fig. 2.6.*

Board damage may prevent it from reaching readiness. In that case you may use the Kernel (Safe) mode jumpers. Kernel (Safe) mode can be enabled for 3.5" IDE (PATA) WD Caviar & Marvell HDD by setting three jumpers at the same time: CS, SLAVE, and MASTER (*Figure 2.6*). The spindle motor in that case does not spin up and the drive switches to a special mode (PSV Mode), which allows ROM reading/writing, editing of the heads map and other operations.

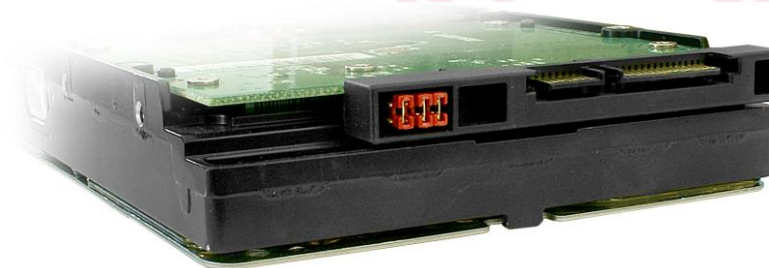
*Fig. 2.7.*

For 3.5" SATA WD HDD you will also have to set three jumpers, but their positions will be different: PM2, OPT1, and OPT2 (*Figure 2.7*). For WD Marvell-ROYL HDD the same three jumpers must be set, though one of them is named differently: PM2, OPT1, and FW.

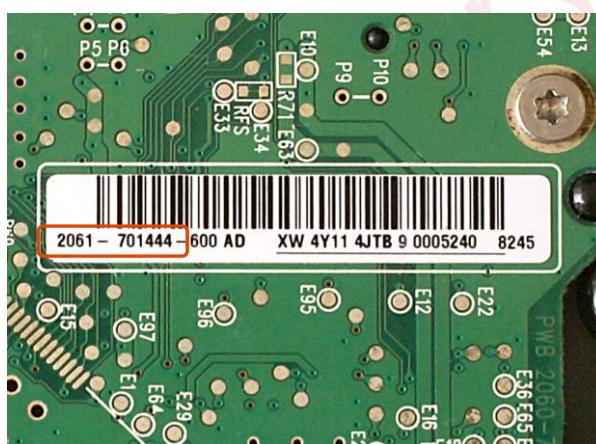
Fig. 2.4.

To restore the original ROM content, you have to install a functional board belonging to the same drive family. You can use the number on PCB label to make sure the right board is selected (Fig. 2.4). Once a compatible board is installed, power is switched on and the utility is started, there are 4 possible variants of HDD behaviour.

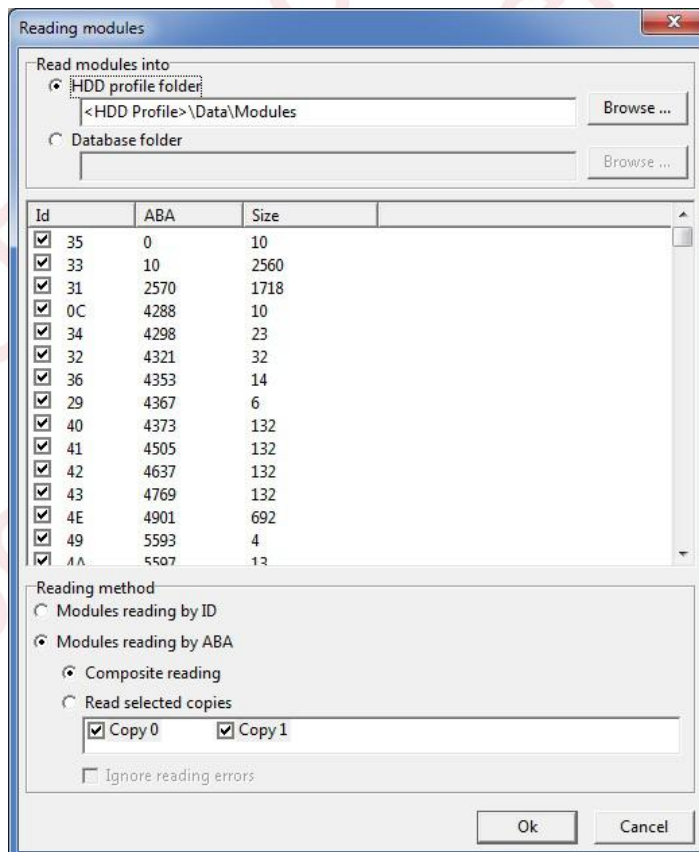
Fig. 2.6 Modules reading by ID.

You can initiate reading of the modules from the menu «Tests» → «Service information» → «Work with service area» → «Reading modules» (enable the option «Modules reading by ID» (Fig. 2.6).

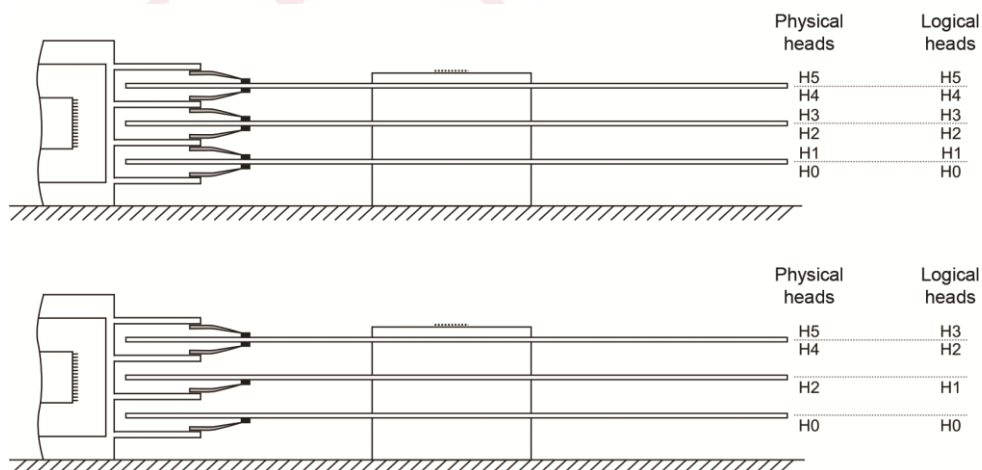
Fig. 2.10. Physical and logical heads numbering.

«Heads configuration» switch determines the heads map source. When the setting «From map» is selected, the utility reads the numbers of physical heads from the bit map byte in ROM (located in module ID=0Ah), while the «Default» parameter makes the utility identify the active physical heads by actual presence of connected heads. Please note, that the «Default» mode does not allow reading the map produced after the polling of existing heads (generally, you can view the generated map in RAM, but in this case the feature searching RAM for the map will find nothing).

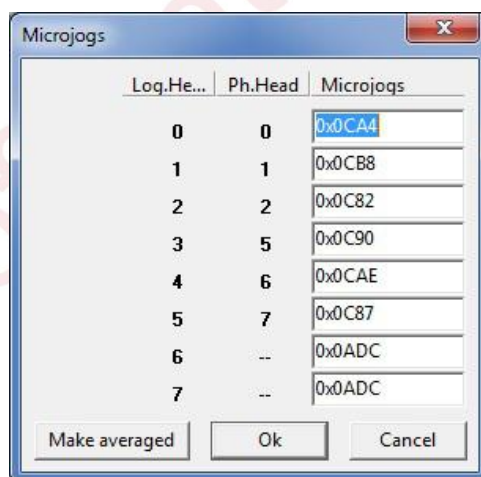
Fig. 2.17.

The dialog (Fig. 2.17) contains the MicroJog values in hexadecimal notation for each logical head<sup>3</sup> (see the footnote on page 21). Our experience tells that a discrepancy of 300 can already be too high so you have to choose a donor having as close values as possible. To estimate a donor drive fitness for a «HOT SWAP» operation, you should write to it a generated «average» module ID=47h and check whether the HDD starts using that module.

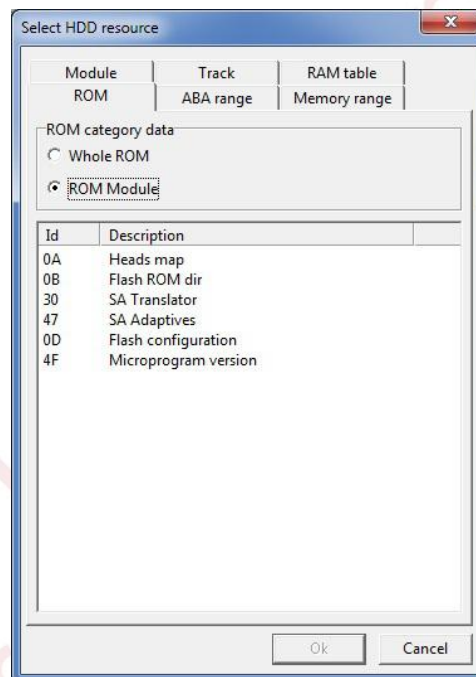
Fig. 3.1.

The utility supports reading and recording of an entire ROM. Read image already contains ROM modules as well, but reading the ROM modules separately makes sense for convenience. To view and edit the data in ROM, you can use the «HDD's resources view and edit» command from the «Tools» menu, having selected the «ROM» tab (Fig. 3.1).

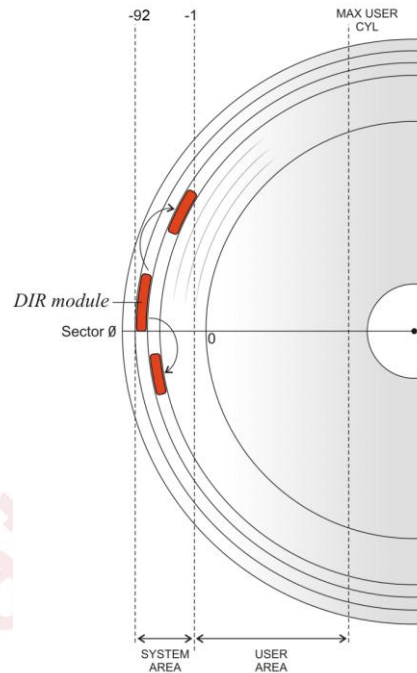
**Fig. 3.5.**

*Fig.3.5* demonstrates a different situation. Tracks with negative numbers are marked from -1 to -92. In the MWD-ROYL-ABA group of families the SA tracks are combined into a long sequence of sectors from cylinder -92 to -1 called a region and addressed by ABA sectors. The region usually begins with module DIR (ID=01) containing the locations of modules relative to the number of the ABA sector beginning the region (there are exceptions to this rule in some HDD). Two identical service area copies are recorded in two first regions corresponding to the logical heads 0 and 1. Regions for other heads are not used. Drives use for defects relocation within regions a system that is very similar to the one employed for the user data area. ROM contains the ID=30h SA translator module while the service area contains a defects table ID=35h. Please note that a portion of track -1 is not formatted (an attempt to read cylinder -1 will return errors while reading) and the area is intended to act as reserve space when sectors shift because of the defects relocated within a region.

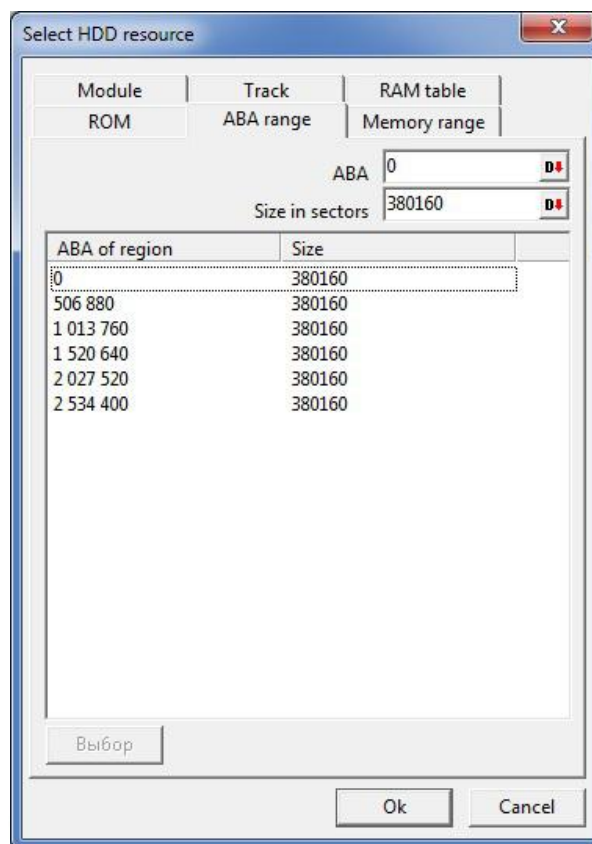
Fig. 3.6.

The utility supports reading and recording of the entire service area region. To do that, use the «HDD's resources view and edit» feature from the «Tools» menu (the «ABA range» tab). You can use the mode to record the whole service area for heads other than the system ones without disrupting the operation logic of the service area translator<sup>1</sup>.

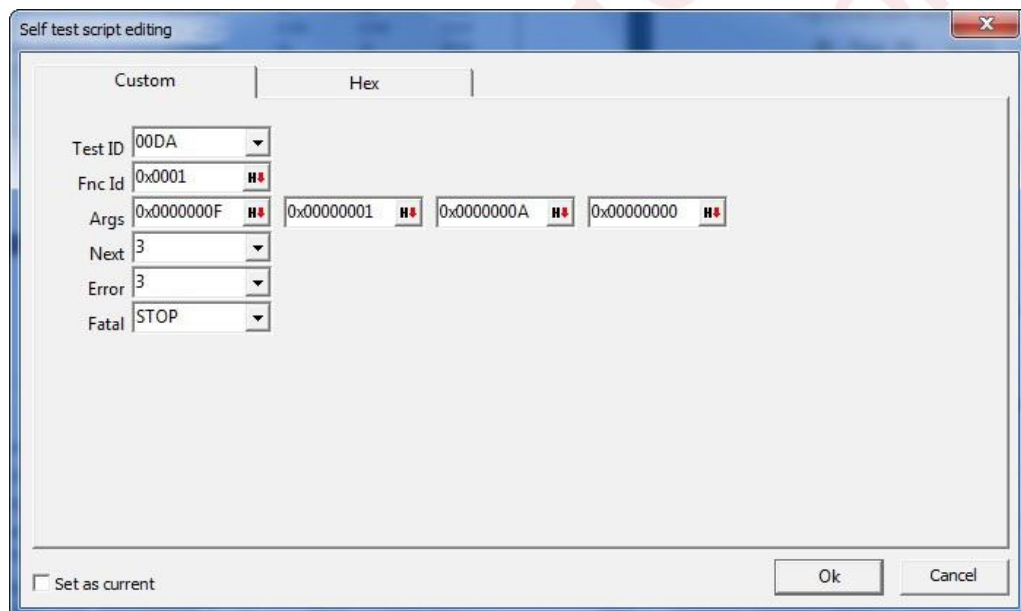
Fig. 4.2.

- ◆ **Test ID** - test number. It also matches the ID of an appropriate service area module containing the program code for the test.
- ◆ **Fnc Id** - test function number.
- ◆ **Args** - a set of arguments for the test.
- ◆ **Next** - step number where the test should proceed in case of successful completion.
- ◆ **Error** - step number where the test should proceed in case of error.
- ◆ **Fatal** - step number where the test should proceed in case of a fatal error (emergency termination).

All bytes of the test control record are editable in the «Hex» tab. Step number marked as «STOP» is a step number variable set to 0xFFFF or -1 in int-notation.

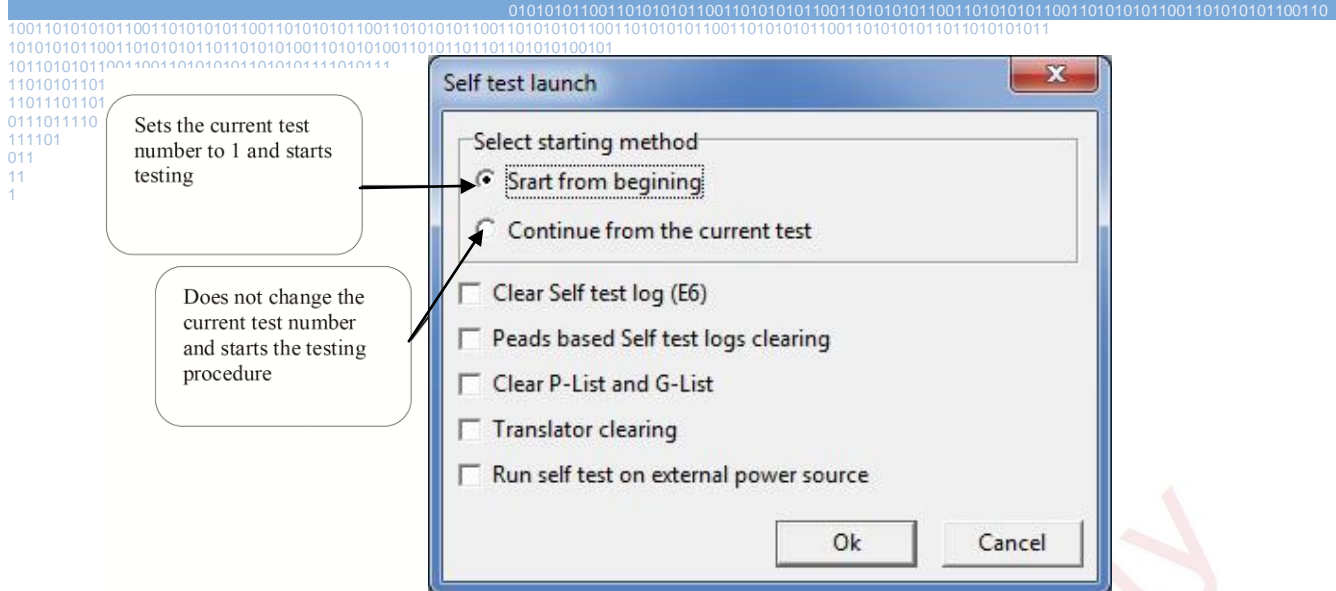
Fig. 4.3.

Before the procedure begins, the utility displays the start settings shown below (Fig. 4.3). First DC test usually expects for several minutes after start (the duration depends upon drive family and the test settings in script) before it actually begins working.

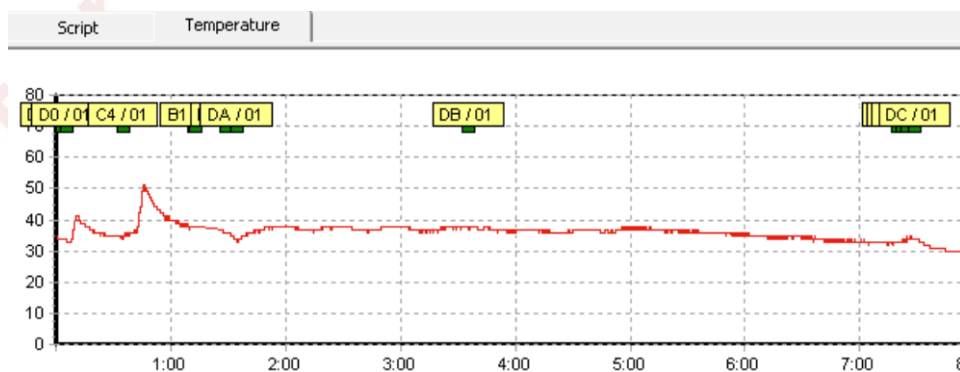
Fig. 4.5

Starting with the Lynx family, 2.5" drives must be warmed up to 50° C to ensure successful completion of the C4 test, which begins the script. Once the test starts, heating can be stopped. The test starts approximately in a minute after a drive reaches 50°. Sample diagram of a Lynx drive that has successfully completed factory self-testing:

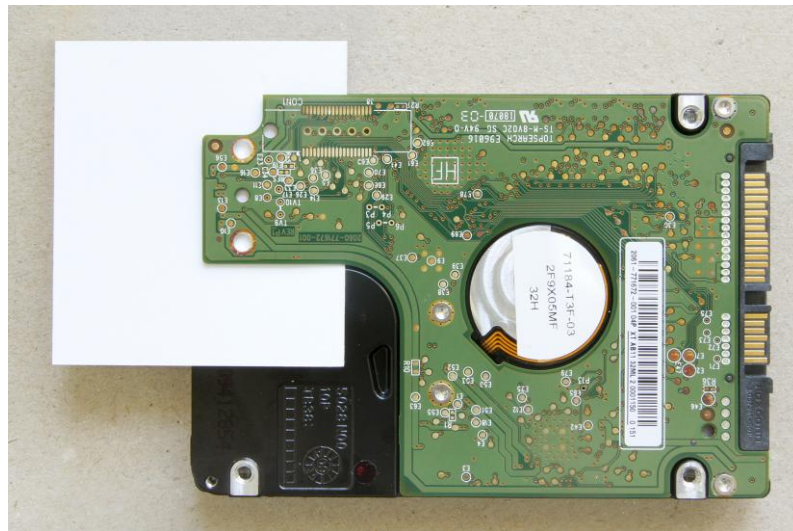
**Fig.8.1. Inserting insulation.**

The HDD will not react to any command in the «busy» state. To access the service area, you have to activate the kernel mode. There is no way to enable the kernel mode only by software means, but you can physically disconnect the PCB from the preamplifier and heads positioner by inserting insulating material between the electronics board and the HDA connector (Fig. 8.1 Fig. 8.). It is essential to leave the spindle motor contacts connected during the procedure to prevent the HDD from freezing during the motor start routine.
